2012 Annual Inspection and Maintenance Report for North Maybe Mine - East Mill Creek Restored Sediment Control Structure

Submitted by:
Nu-West Industries, Inc. and Nu-West Mining, Inc.

Submitted to:
United States Department of Agriculture, Forest Service

December 2012

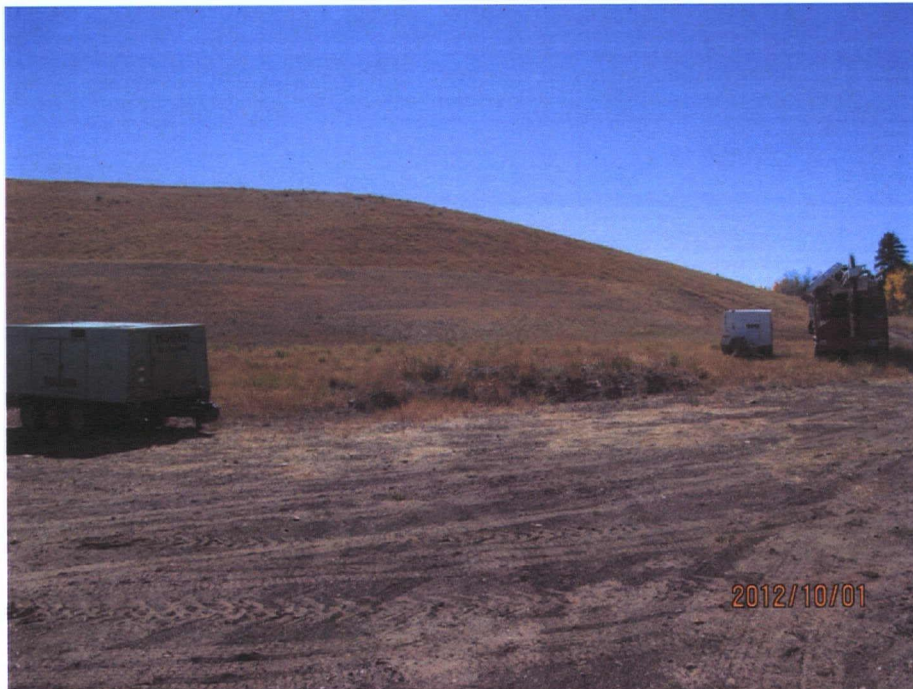
Photo taken looking south, showing the waste consolidation area. The area at the toe of the waste consolidation area is being utilized by the North Dry Ridge exploration drilling crews.

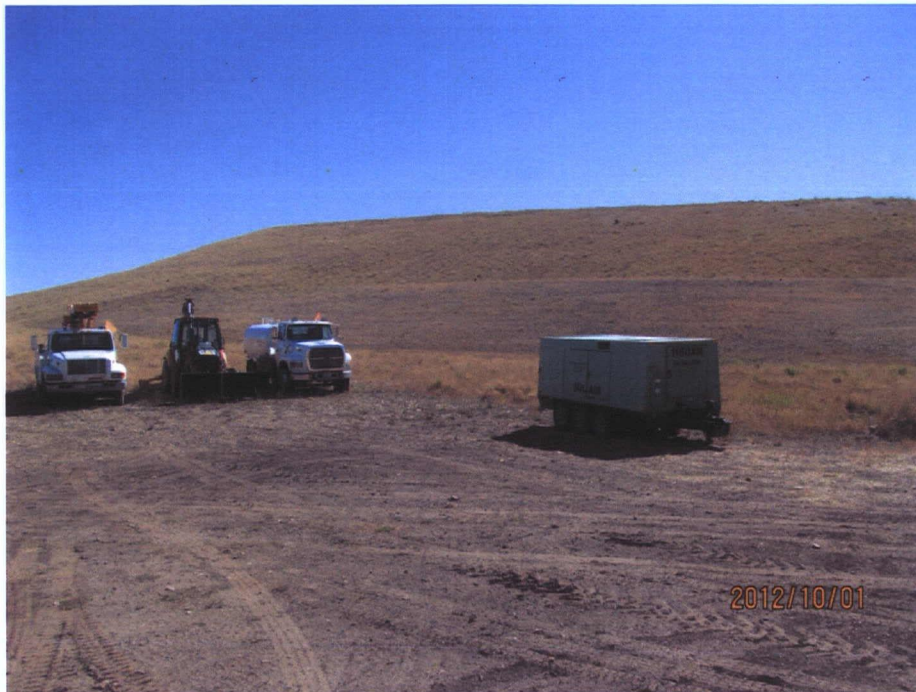
Photo taken looking southeast, showing the waste consolidation area. The area at the toe of the waste consolidation area is being utilized by the North Dry Ridge exploration drilling crews.

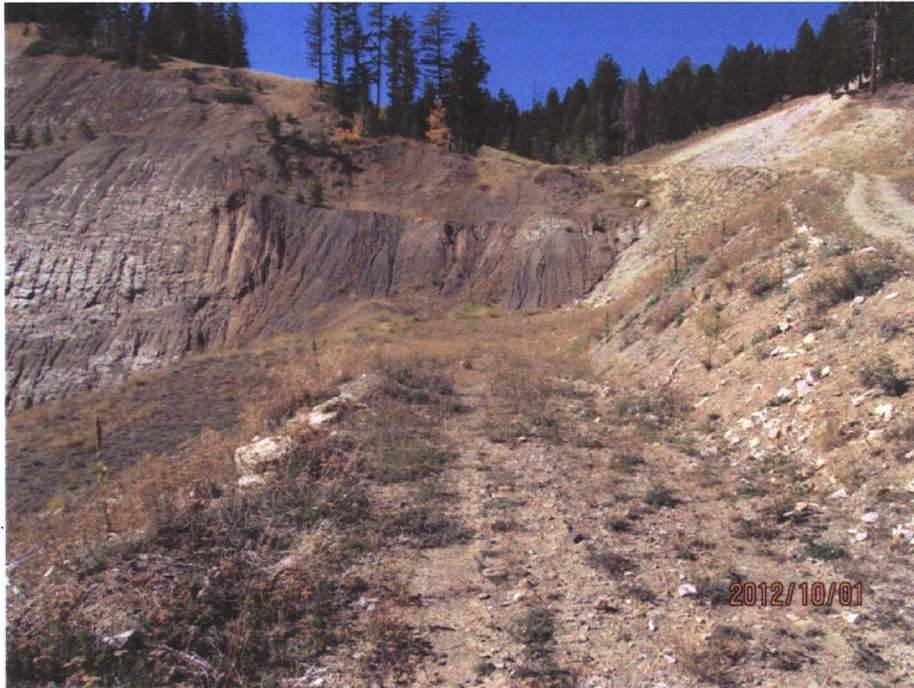
Photo taken looking west, showing the growth media borrow area located at the north end of the pit. This area is holding up well showing no signs of erosion and vegetation becoming established.

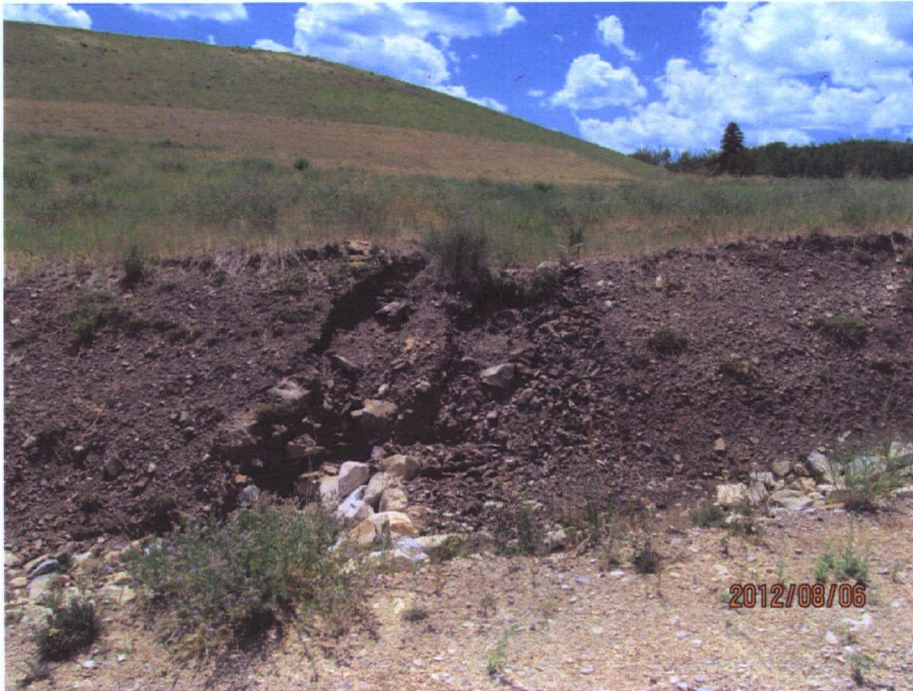
Photo taken looking south, showing an erosion rill that formed from water running off the area below the waste consolidation area.

Photo taken looking south, showing the repaired erosion rill that formed from water running off the area below the waste consolidation area.

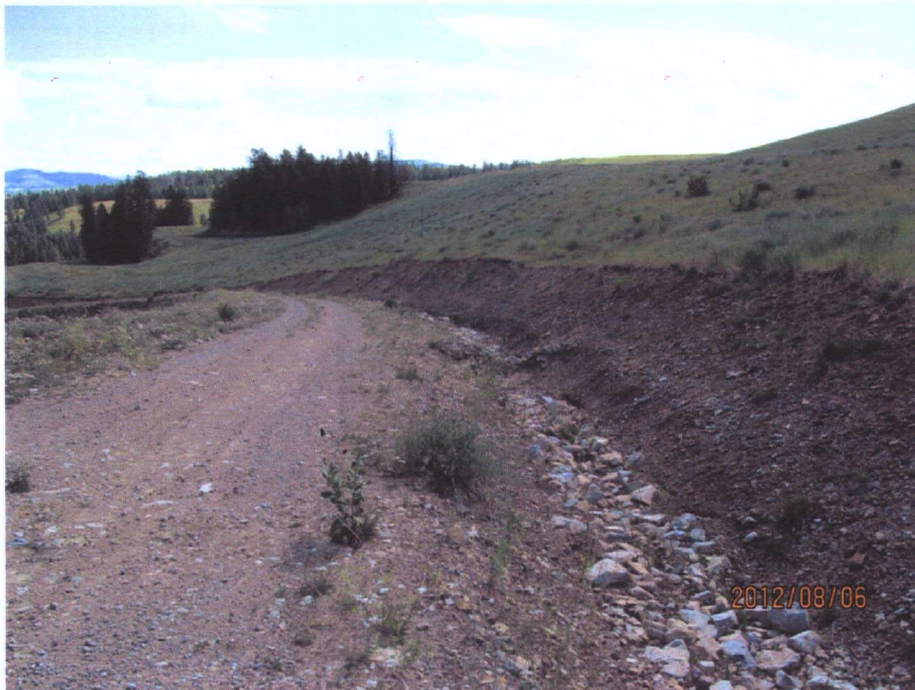
Photo taken looking east, showing the upper portion of the access road. Ditch experienced some erosion and scouring from a recent storm event.

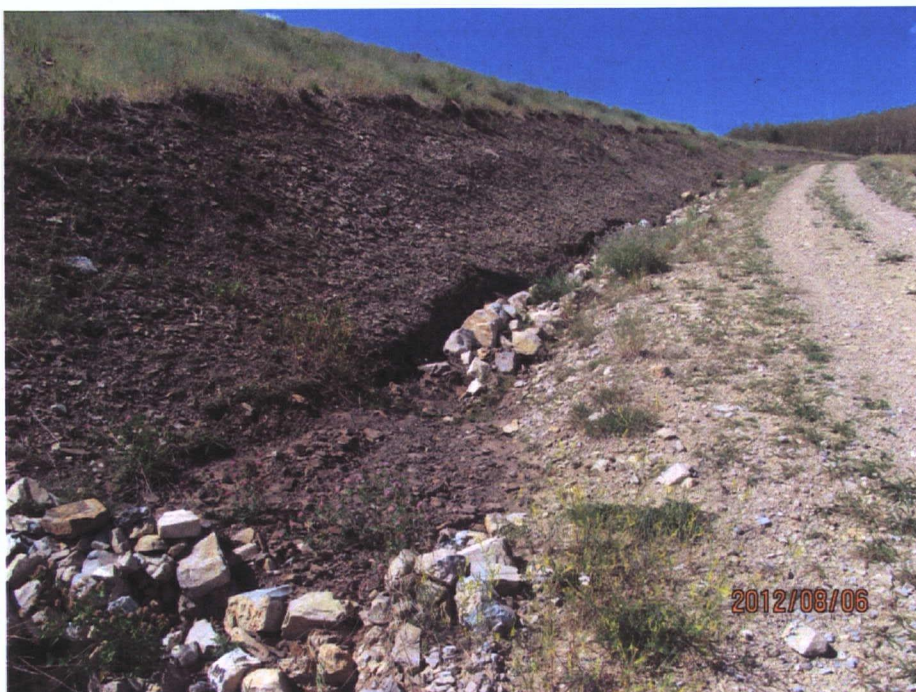
Photo taken looking west, showing the upper portion of the access road. Ditch experienced some erosion and scouring from a recent storm event.

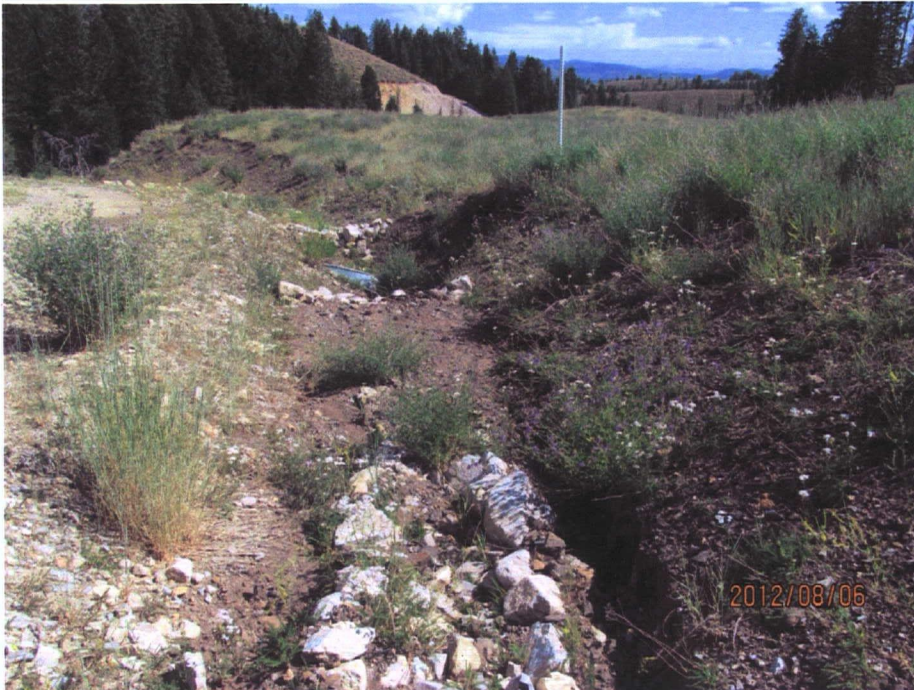
Photo taken looking east, showing the upper portion of the access road. Ditch experienced some erosion and scouring from a recent storm event.

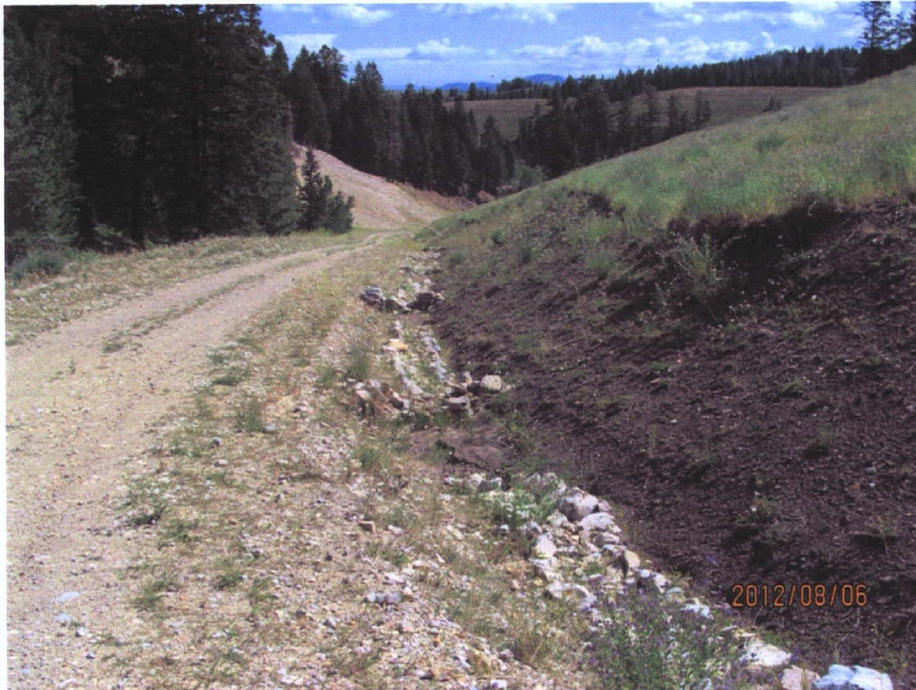
Photo taken looking east, showing the upper portion of the access road. Ditch experienced some erosion and scouring from a recent storm event.

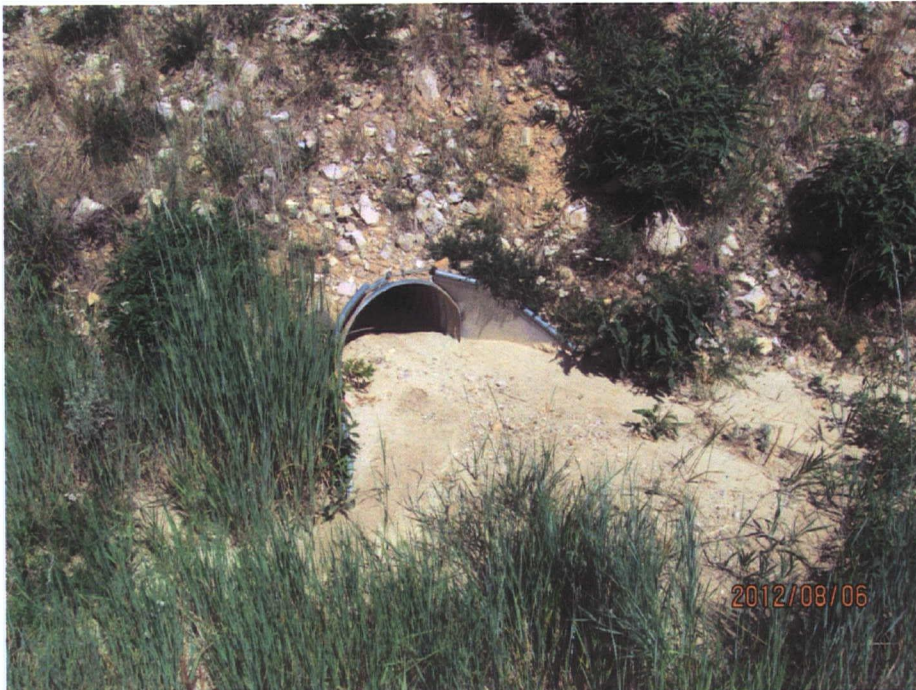
Photo showing an access road culvert partially filled with sediment from a recent storm event.

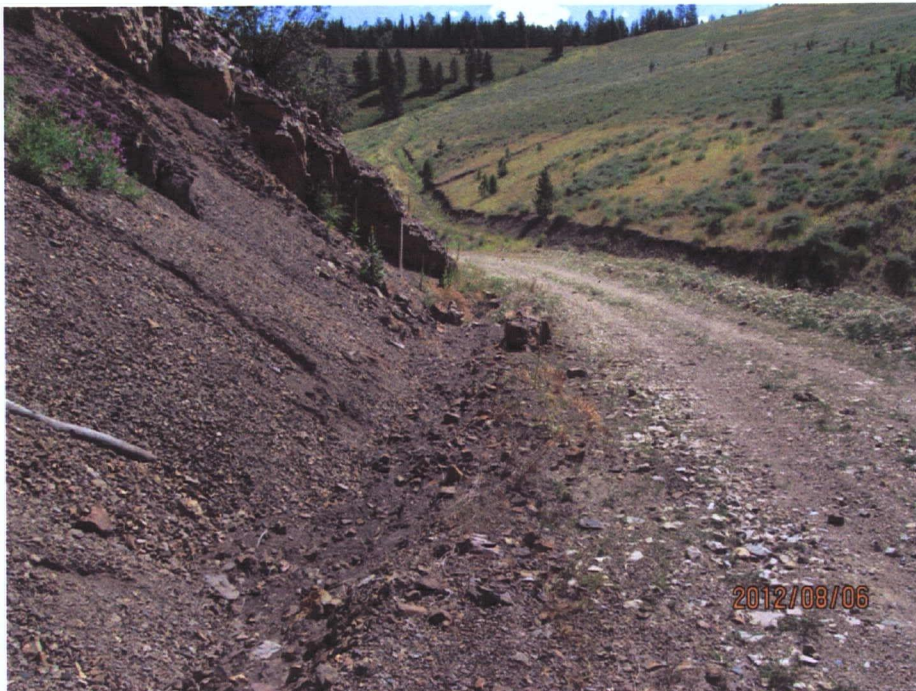
Photo taken looking east, showing the middle portion of the access road along the North Maybe Pit endwall. Ditch experienced some erosion and scouring from a recent storm event.

Photo taken looking east, showing the middle portion of the access road along the North Maybe Pit endwall. Ditch was repaired by cutting and cleaning out the flow line.

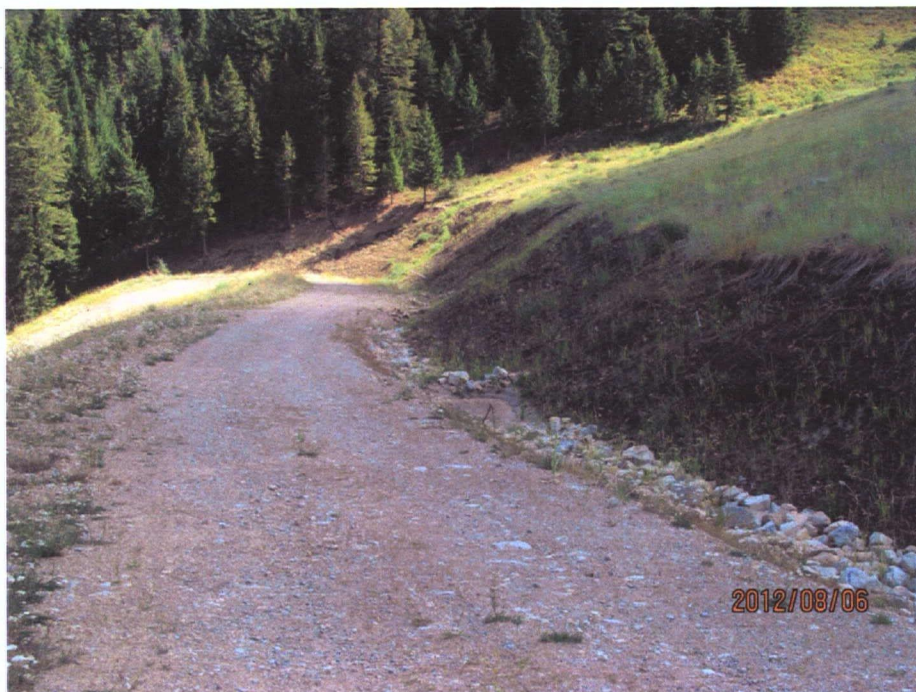
Photo taken looking east, showing the lower portion of the access road. Ditch experienced some erosion and scouring from a recent storm event.
